Case study

Eye Veterinary Clinic, Marlbrook, near Leominster, Herefordshire

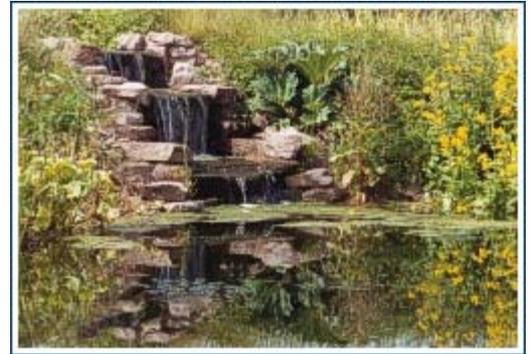
The green-field site chosen for the new, state of the art, Eye Veterinary Clinic, is in the corner of a large grass field that is virtually flat. There are no watercourses nearby and the red Herefordshire Marl soil is renowned for its poor porosity. Whatever we did, all wastewater and run-off would have to be treated and disposed of on the site. A septic tank and soakaway drains for sewage disposal were ruled out early on as an option. Our solution was to design and install a 3-stage combination vertical and horizontal flow reed-bed system for the treatment of the sewage generated by staff and visitors to the Clinic, and dispose of treated effluent via a surface ground wetland soakaway. All veterinary waste is collected separately and collected for disposal as a special waste. The high quality effluent produced by the reed-bed is discharged into a large pond with a waterfall at one end of a long mound constructed from the spoil excavated in making the pond. The pond and the waterfall face towards the main entrance of the Clinic and provide a restful calming setting for anxious pet owners.

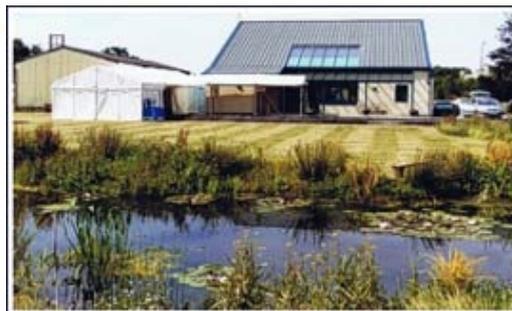
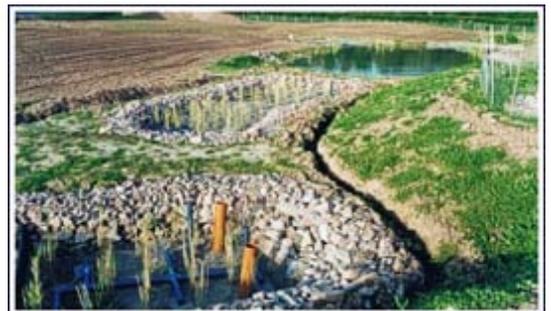
Roof water from the building, and the run-off from the tarmac car parking areas run along a winding vegetated ditch into the pond. The water in the pond is constantly being recycled via a gravel filter bed and the waterfall; a process which cleans the water further and keeps it oxygenated. In heavy rain and winter conditions excess water in the pond overflows via a broad gravel bed into an unlined wetland area planted with willows and bunded around its margins. Here clean excess water soaks away over time. In the 6 years since this system was built the wetland has filled in storm conditions but never once overflowed.
